Volume II-Problem Area Analysis

Luzerne County Act 167 Phase II

Stormwater Management Plan

June 30, 2010

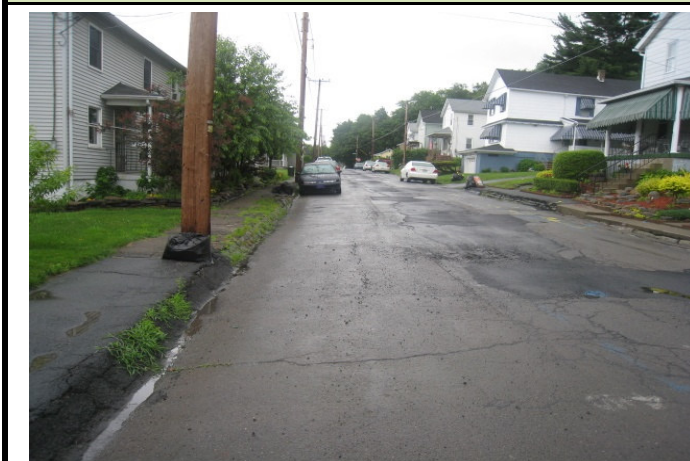
Description
	700 block of Grove Street. <i>The street does not</i> have stormwater collection and conveyance facilities.

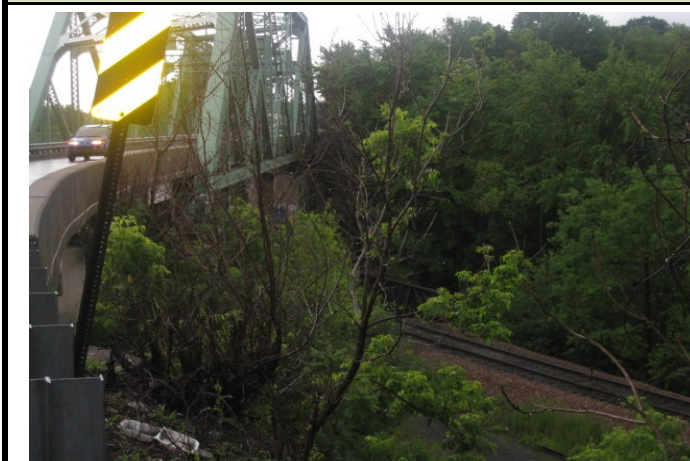
Description
Looking at the downstream face of the SR 11 bridge. Railroad tracks located on both sides of the creek.

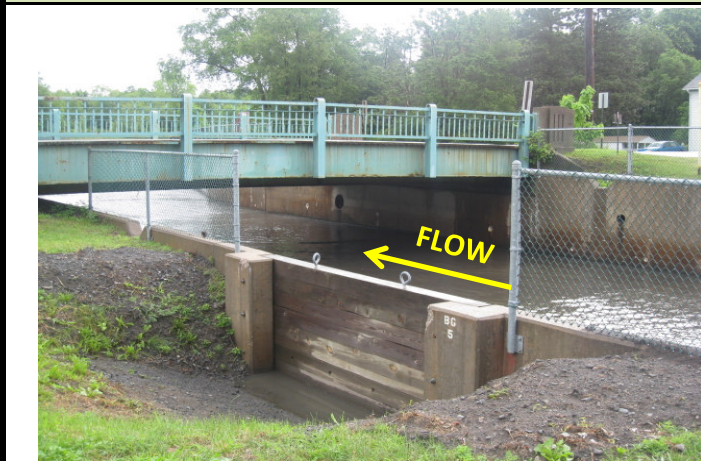
Looking downstream at the York Avenue steel bridge. Narrowing of the channel at the bridge could result in reduced velocity and sedimentation.

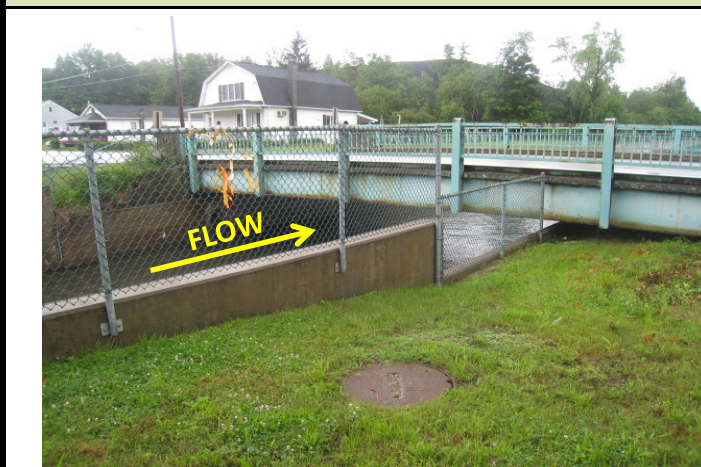
Looking upstream at the York Avenue steel bridge. Ice jams were not observed due to the season but could be caused by the narrowing of the channel.

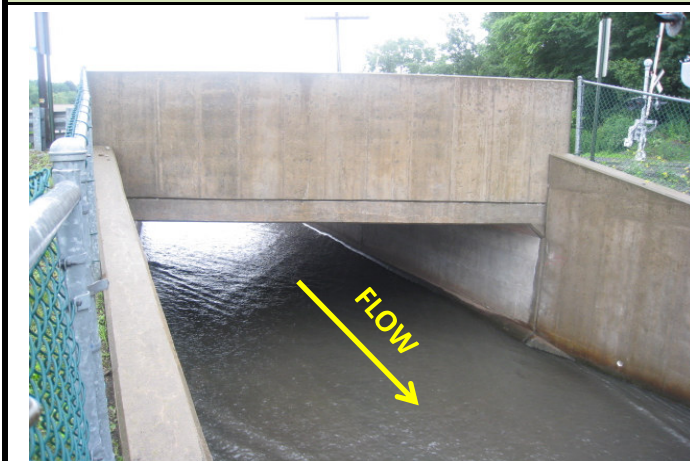
Description
Ddownstream face of the McAlpine Street box culvert. The railroad tracks are located to the right in the photo.

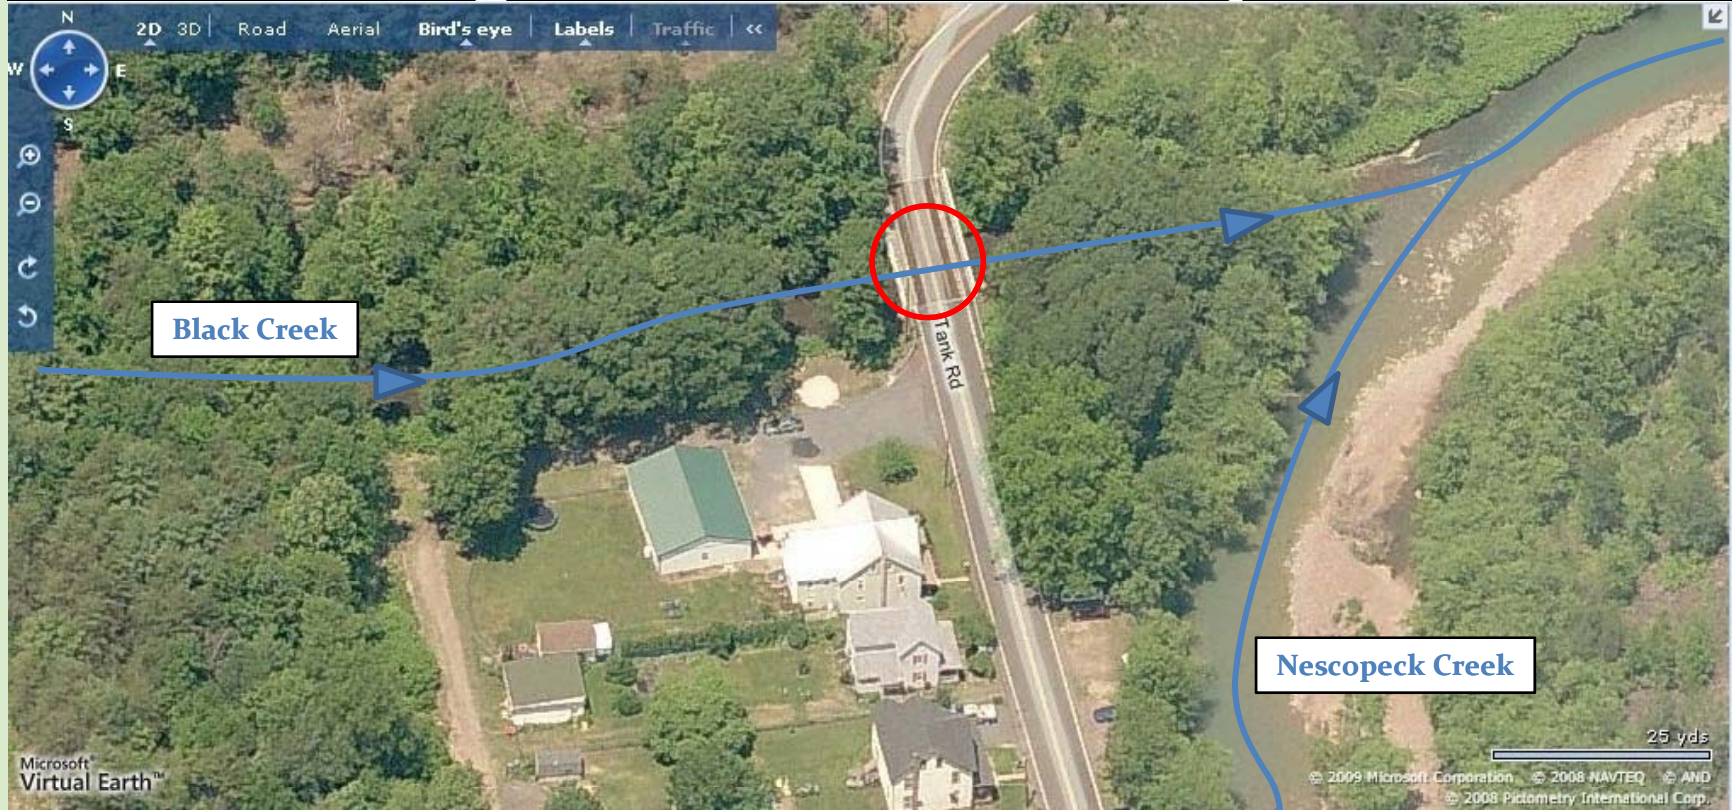
Problem Area	Municipality	Sub Watershed	Stream Name	Preferred Solution
BCR001	Black Creek Twp	Nescopeck	Black Creek/ Nescopeck Creek	Proposed Solution: (B)

Explanation: The Conservation District notes in the problem area worksheet that the channel at the upstream face of the bridge became clogged with sediment. Based upon site observations, the problem looks to be the bridge over Black Creek. Options for correcting this condition include maintenance to remove accumulated sediment and replacing the bridge with a structure with an appropriate hydraulic opening.

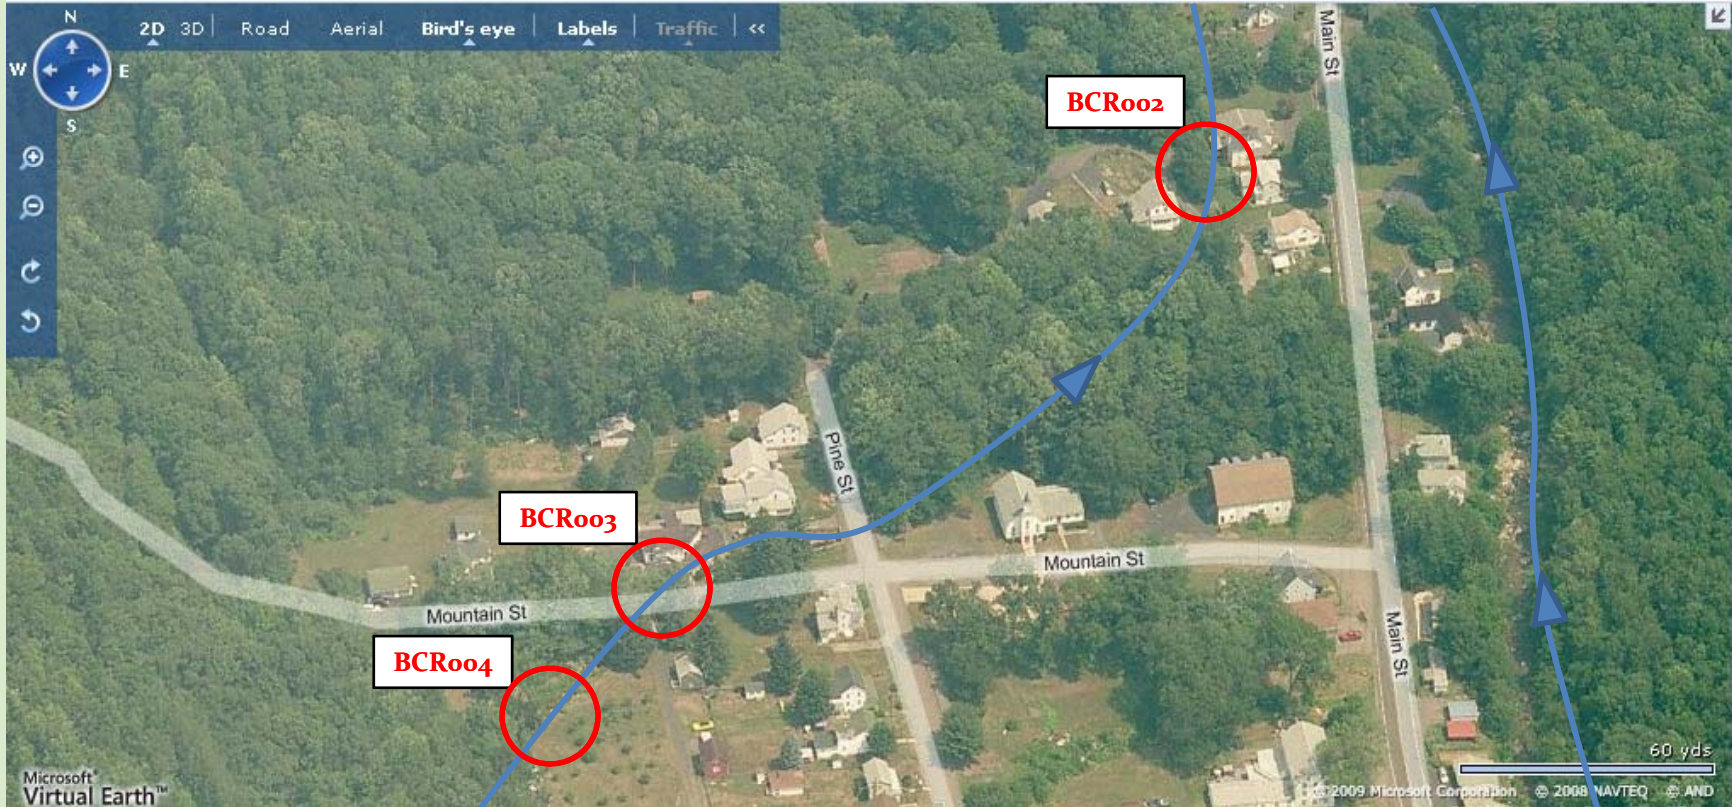
Problem Area	Municipality	Sub Watershed	Stream Name	Preferred Solution
BCR002, BCR003, BCR004	Black Creek Twp	Nescopeck	Unnamed Tributary to Black Creek	Proposed Solution (N/A)

Explanation: The problem at this location is regional flooding, which is caused by what appears to be development and channelization of the floodplain. Problems include flooding of nearby roads and homes. Options for correction include construction of a regional detention facility upstream of the area, applying specific floodproofing measures to the homes, or restoring the natural floodplain.

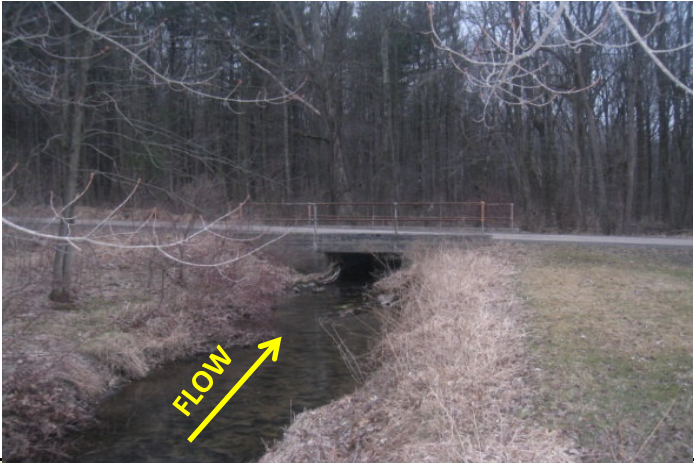
<div style="width: 50%; padding-left: 10px;"> <p>Looking at the upstream bridge face. There is minimal buffer on the right bank. Downstream of the bridge is a forest; however, a stone retaining wall forms a levee along the left bank.</p> </div> </div>

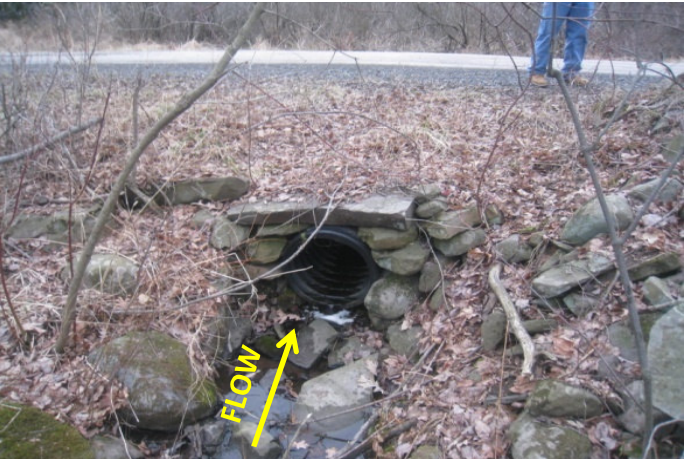
<div style="width: 50%; padding-left: 10px;"> <p>Upstream culvert face. Culvert is an HDPE pipe in good condition.</p> </div> </div>

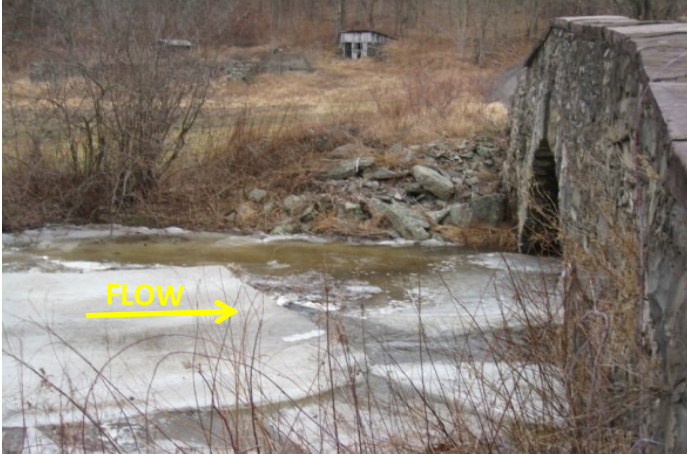
<p>Upstream bridge face. The bridge opening is likely undersized and unable to pass larger storms.</p>

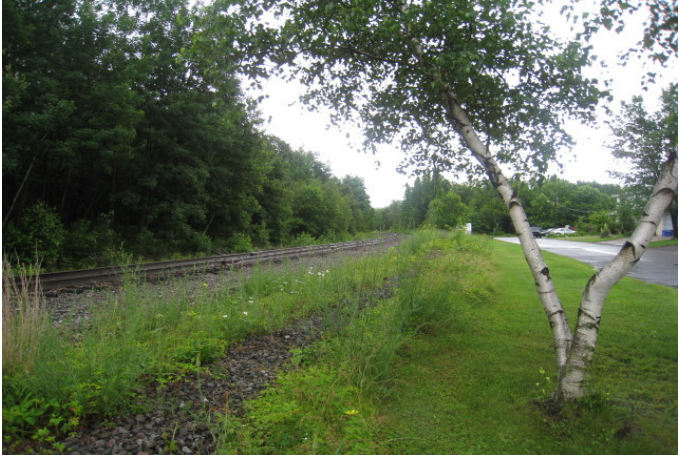
<div style="width: 50%; padding-left: 10px;"> <p>Looking south along the railroad tracks that run parallel to Oak Street. Note the railroad tracks are at a higher elevation than the road which may contribute to the drainage problems.</p> </div> </div>

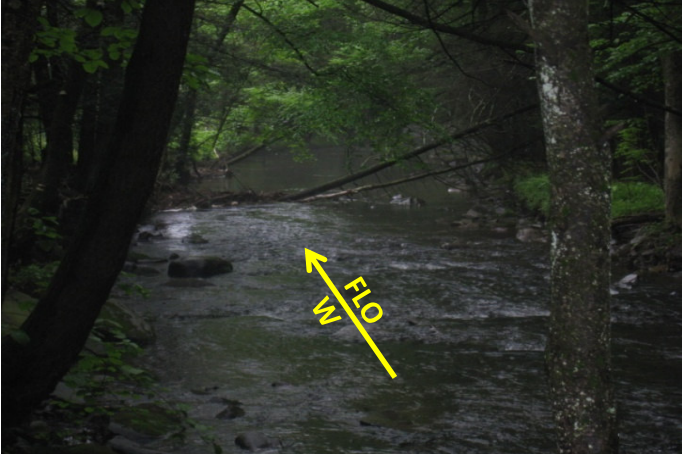
<div style="width: 50%; padding-left: 10px;"> <p>Looking downstream, streambank erosion is present throughout the area. Streambanks under cut, which resulted in trees being undermined.</p> </div> </div>

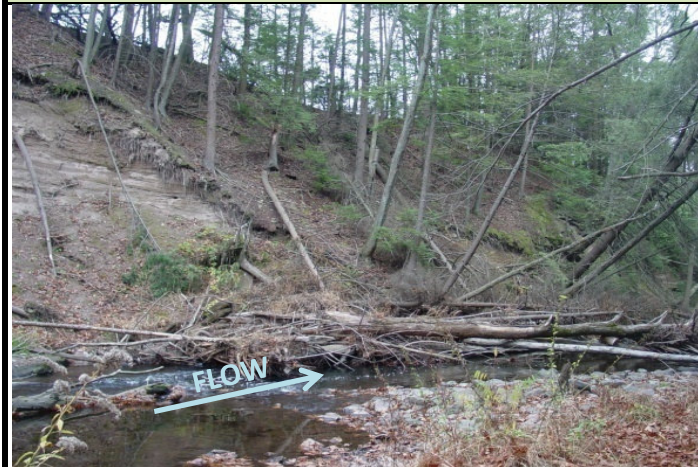
Description
Looking downstream. The left bank has severe erosion. The source of these problems is believed to be the steep slope of the bank, which does not have sufficient erosion protection. The eroded bank has undermined trees, which have fallen and caused blockages to stream flow.

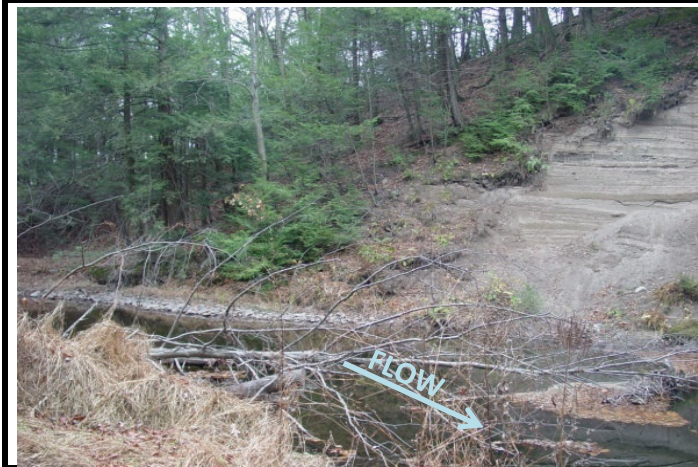
Description
Looking upstream at the eroded stream bank.

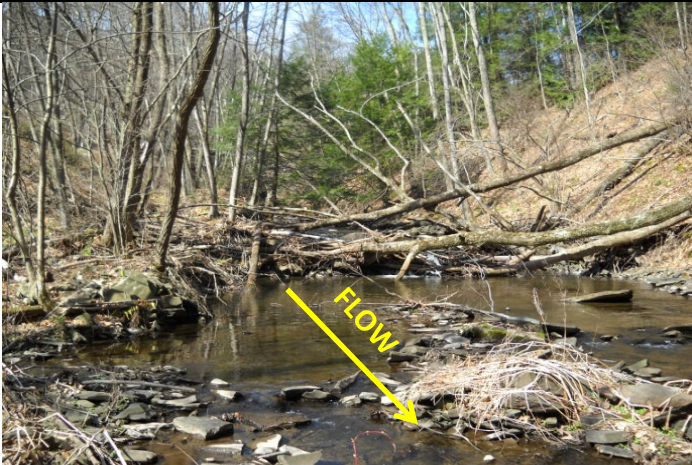
<p>Looking upstream towards obstruction. This obstruction is approximately 500 feet downstream of Old Tavern Road Bridge. Debris/ downed trees are depicted at the bottom of steep banks. Debris and sediment bars are noticeable as well.</p>

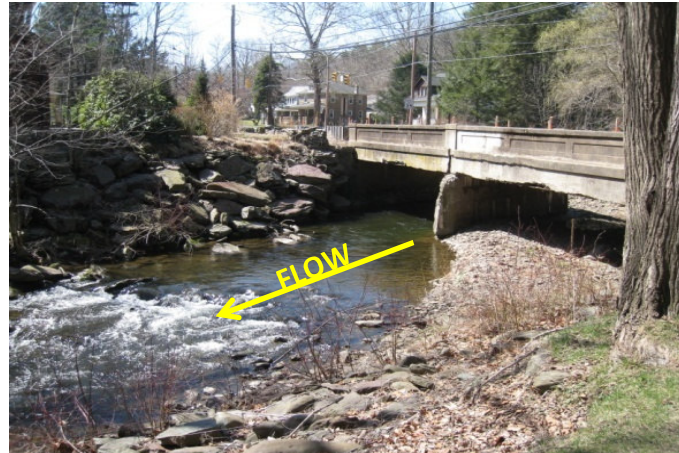
Description
	Looking at downstream bridge face. Flow is concentrated under the span to the left. Sedimentation is visible under the right span. The rock retaining wall along the left span appears to be failing due to undermining.

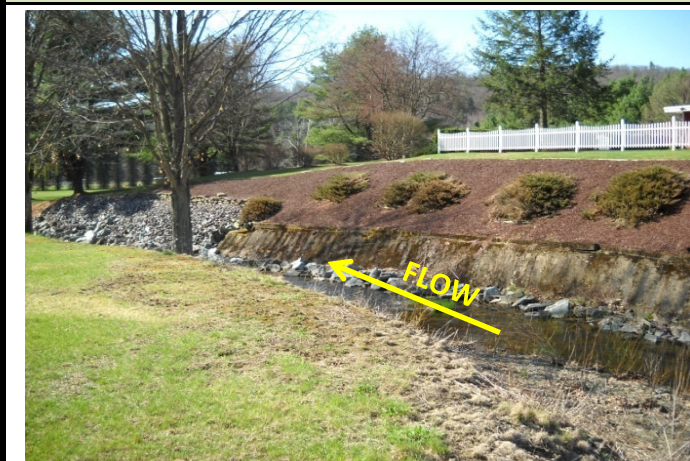
Description
Looking downstream approximately from the Main Road Bridge. The collapsed gabion wall has been replaced along with additional riprap.

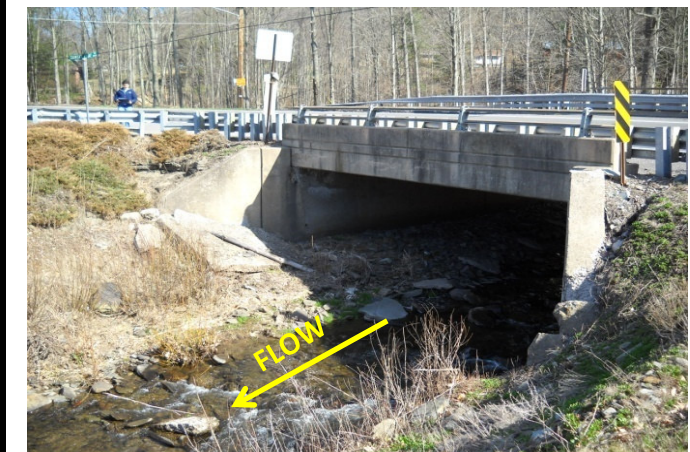
Description
Downstream face of Main Road bridge. Sedimentation is visible under the bridge which is most likely caused by upstream erosion at problem area HUN012.

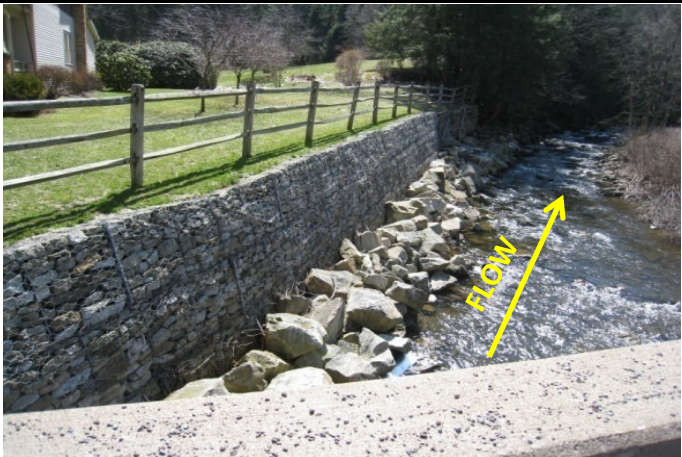
Description
	Looking Downstream at left (eastern) bank. This bank is heavily armored to protect the house. This was done to prevent bank erosion and the house from settling. Both the riprap and the gabion wall appear new, which suggests recent work.

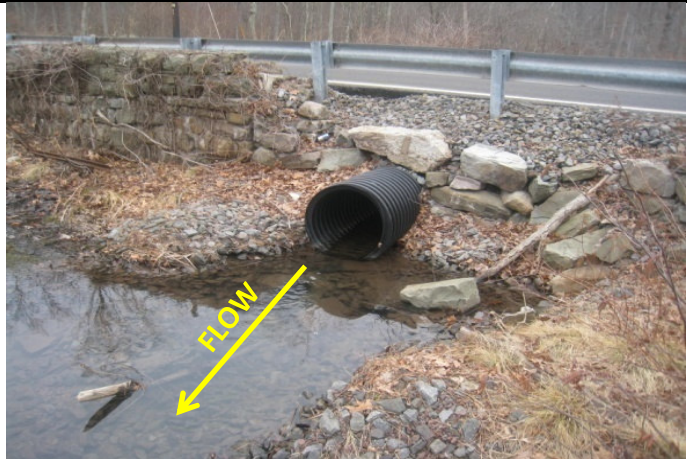
<p>Looking upstream at culvert outlet to Ice Lake. The culvert drains directly to Ice Lake. High water levels in the lake will reduce the conveyance capacity of this culvert.</p>

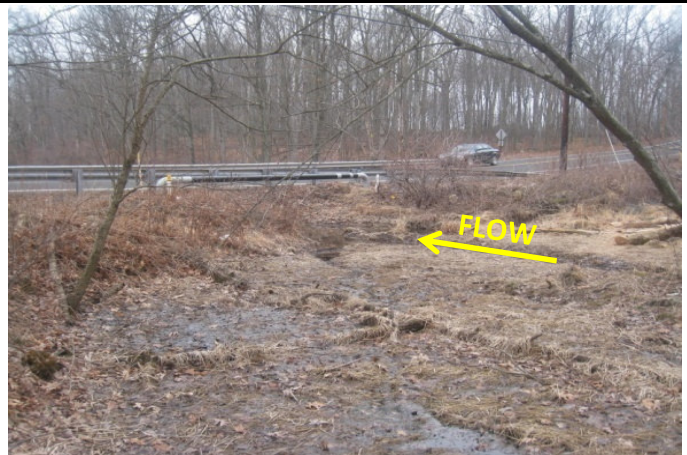
<p>Looking downstream at culvert inlet under Nuangola Road. Evidence of surface water ponding is noted in this location.</p>

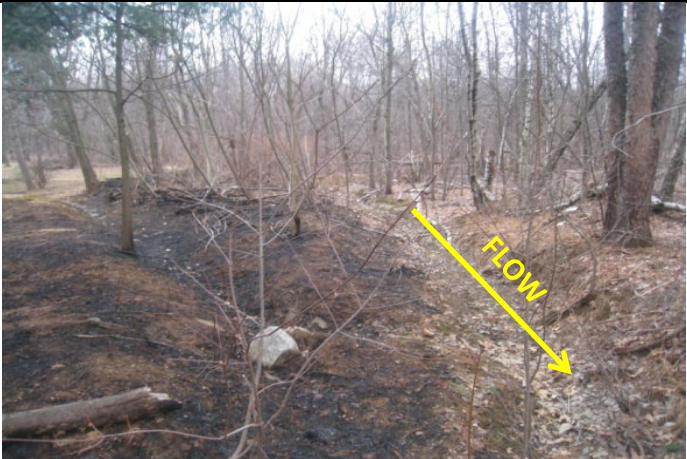
</div> <div style="width: 50%; padding-left: 10px;"> Swale behind property owner's home. This area reportedly floods during large storm events. The most recent event occurred in 2006. The culvert inlet at the end of this swale is believed to connect to the storm sewer in front of the house. According to the homeowner, the culvert has been recently replaced. </div>

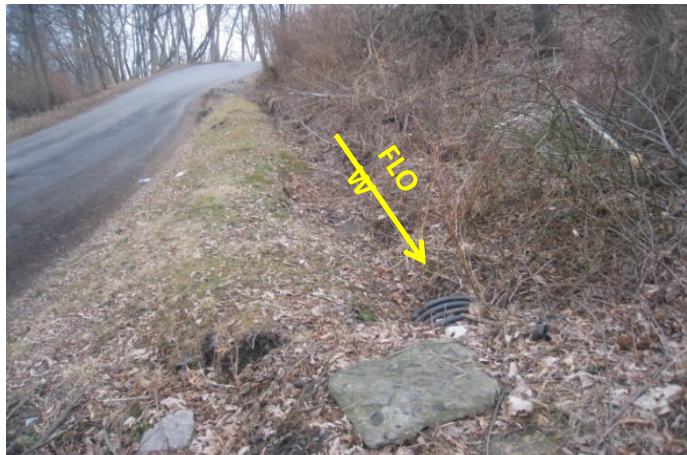
</div> <div style="width: 50%; padding-left: 10px;"> Roadside swale along Beaumont Street. According to a homeowner, the swale flows into the culvert shown and into another swale before finally entering the storm sewer. During the field observation, neither the outlet to this culvert nor the downstream swale could be located. </div>

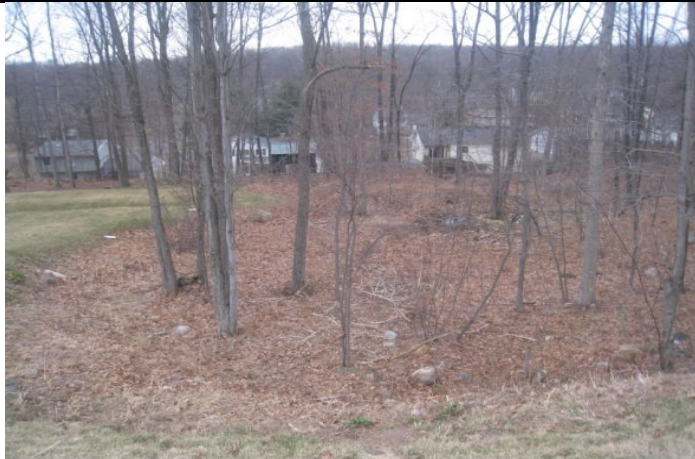
</div> <div style="width: 50%; padding-left: 10px;"> <p>Looking north at the stormwater basin. Numerous trees are shown within the basin footprint and a defined swale leading to the outlet structure. The outlet structure did not include a trash rack and sediment was observed to be obstructing the outflow from the basin.</p> </div>

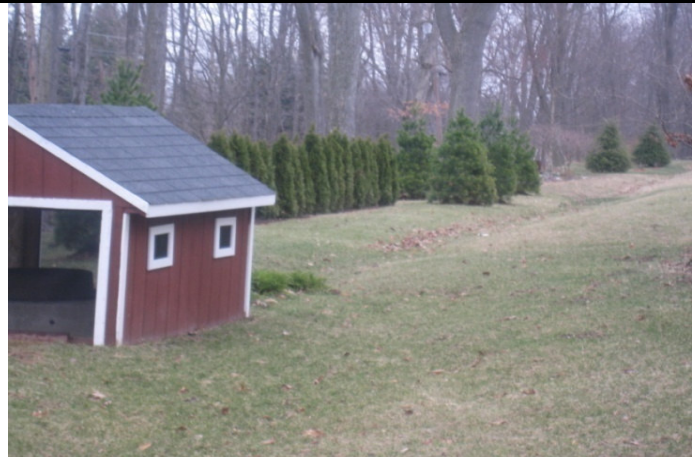
</div> <div style="width: 50%; padding-left: 10px;"> <p>Inflow swale to Basin. This swale passes through several residential backyards. The small structure in the photo is constructed within the swale area, which may cause the swale to be overtopped and runoff to flow through adjacent properties.</p> </div>

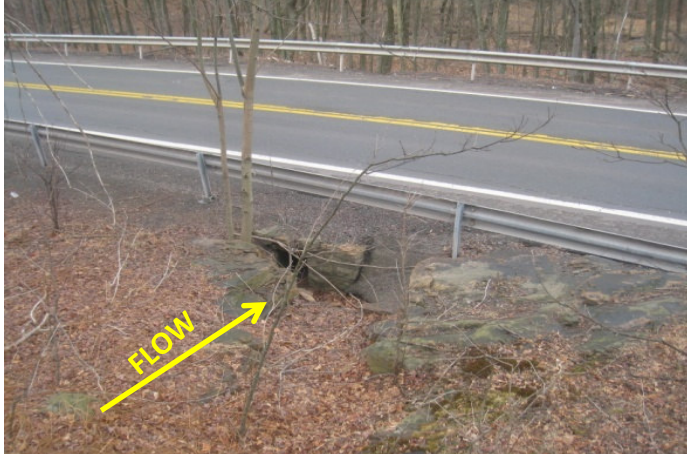
</div> <div style="width: 50%; padding-left: 10px;"> <p>Photo of culvert inlet crossing SR 437. Runoff crosses beneath Church/Tunnel Road, within swale to this culvert. Swale is not well defined and possible undersized culvert would cause ponding and eventual overtopping and flooding of SR 437.</p> </div> </div>

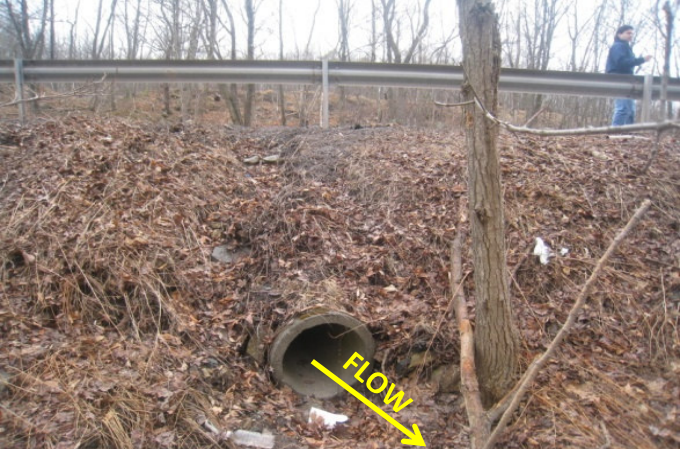
</div> <div style="width: 50%; padding-left: 10px;"> <p>Culvert outlet under SR 437. It was observed that the outlet diameter of the culvert was larger than the inlet diameter.</p> </div> </div>

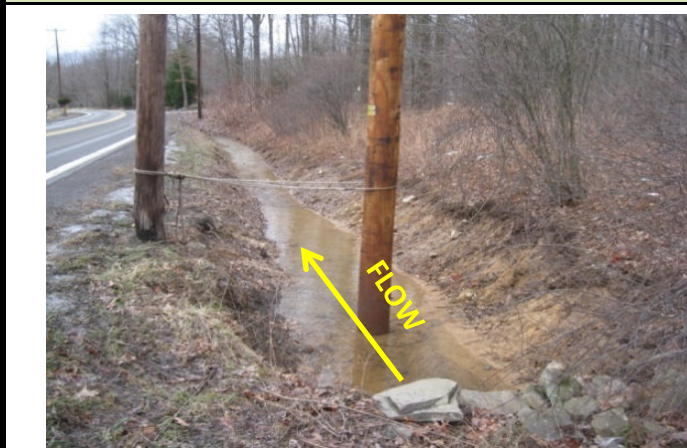
Description
Downstream culvert appears to be undersized and subject to frequent clogging. The swale sideslope to the right appears to be unstabilized, causing erosion and downstream sedimentation. Utility pole installed in center of swale may be causing impediment to flow.

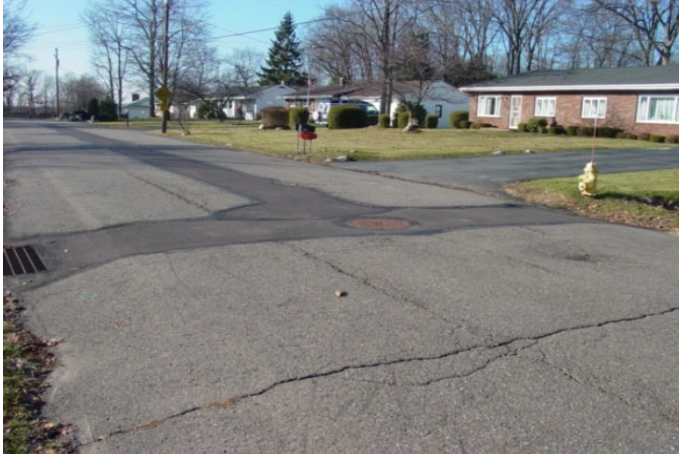
</div> <div style="width: 50%; padding-left: 10px;"> <p>Oak Drive looking towards S. Main Road. The sewer system is clearly visible from the road. The road is crowned and storm sewer inlets are found on both sides of the street. Runoff may be bypassing inlets as runoff travels down the street.</p> </div> </div>
